Dzilh-Na-O-Dith-Hle Community School

Eligible for Replacement School Construction Consideration

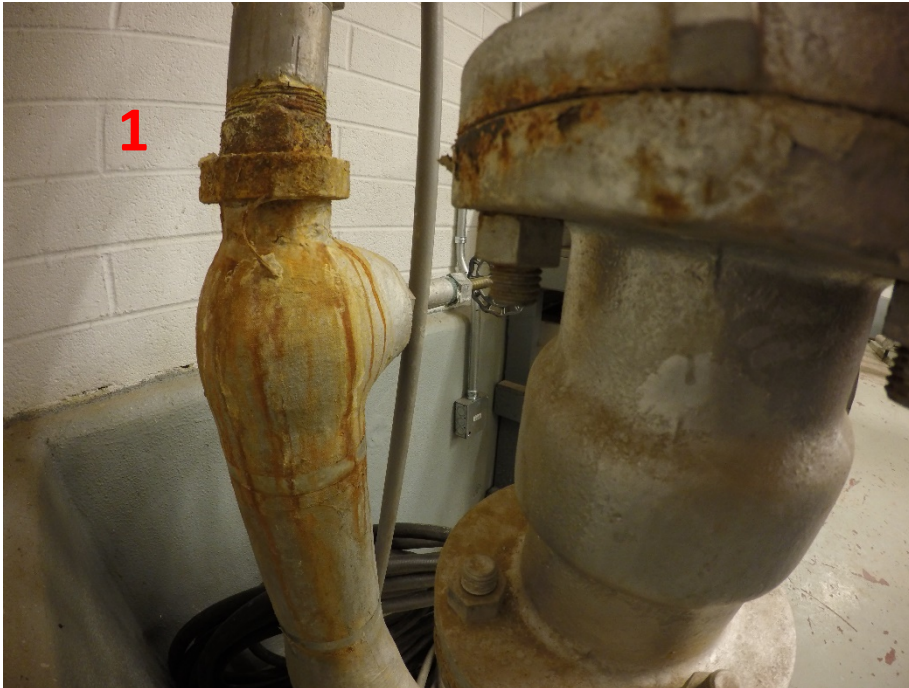
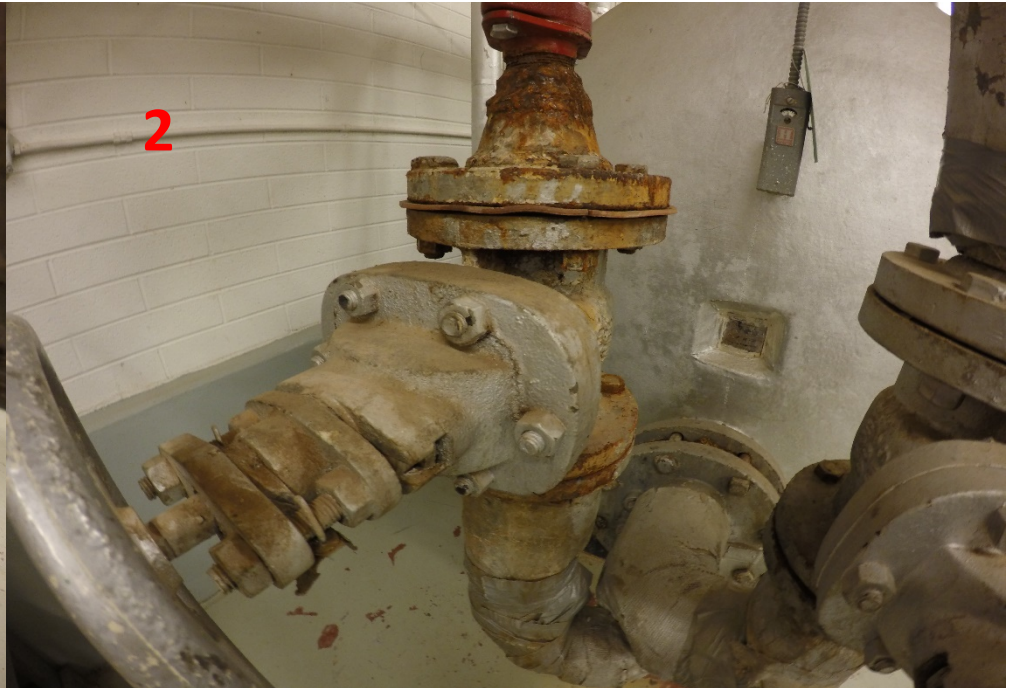
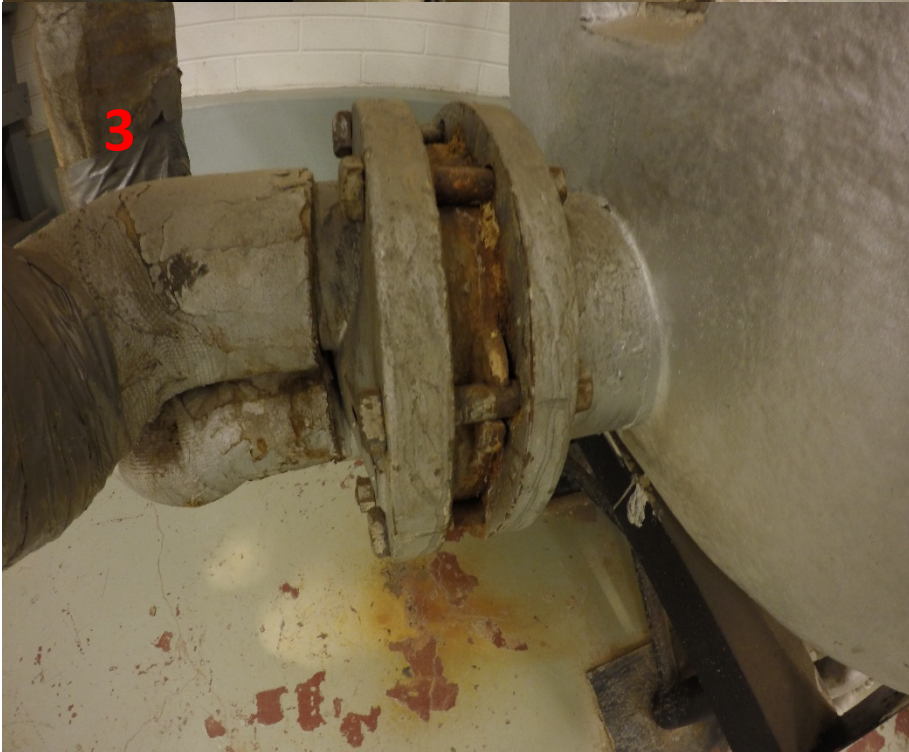
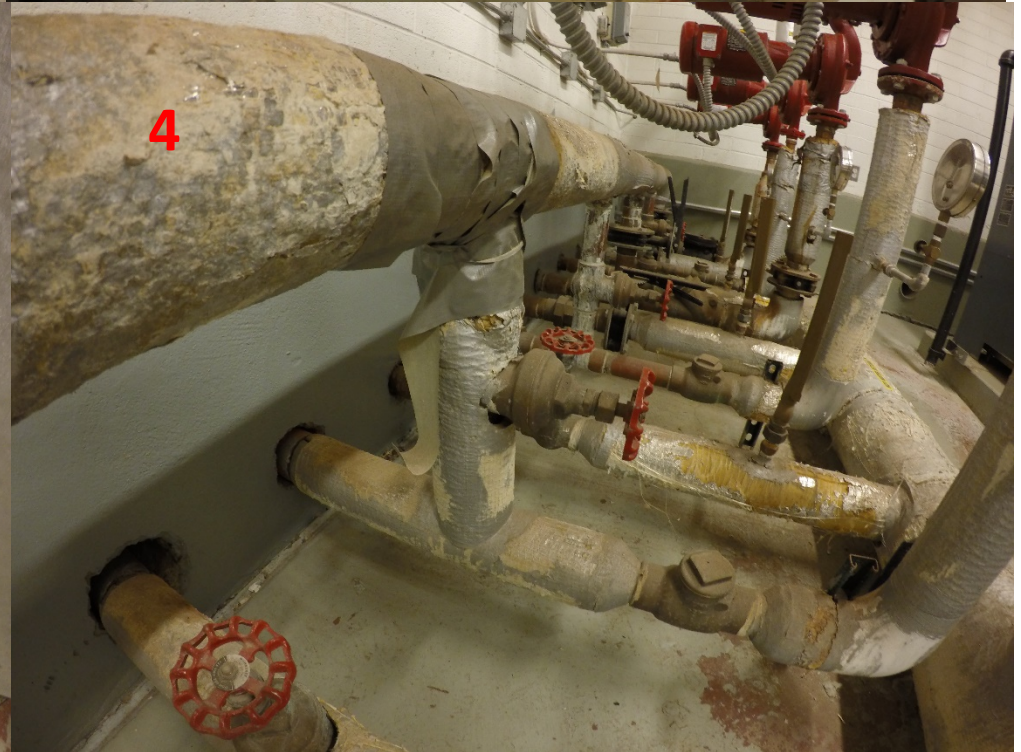
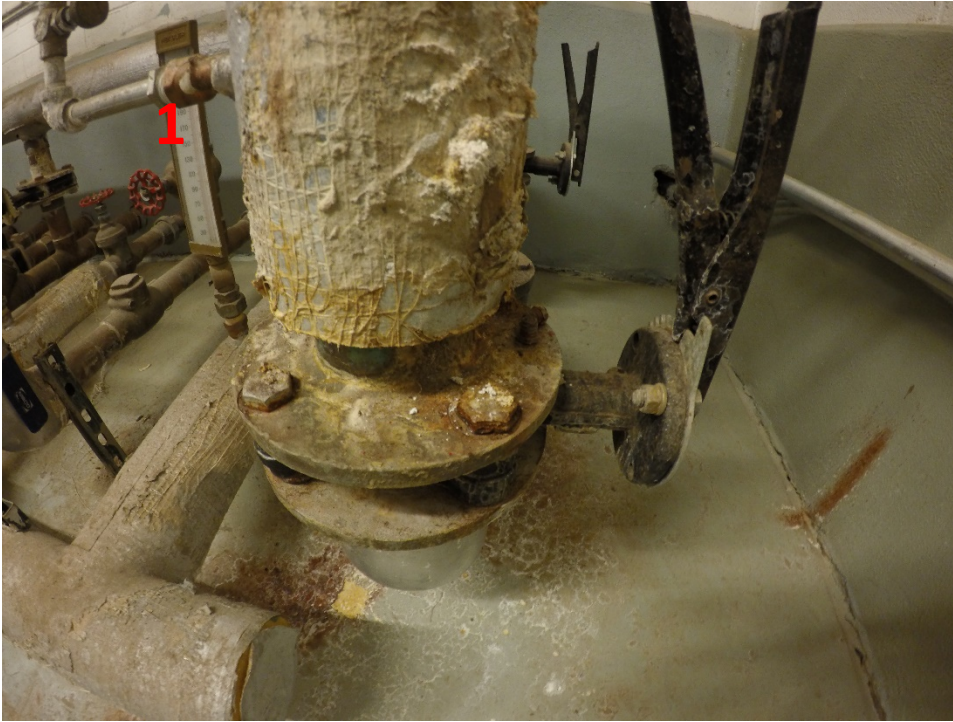
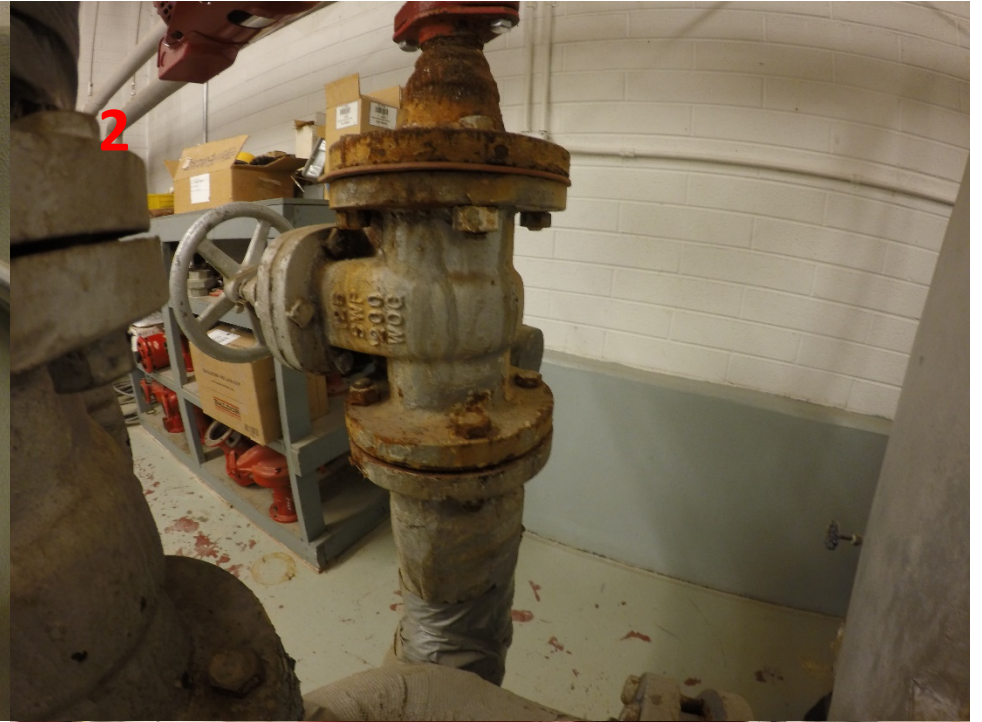
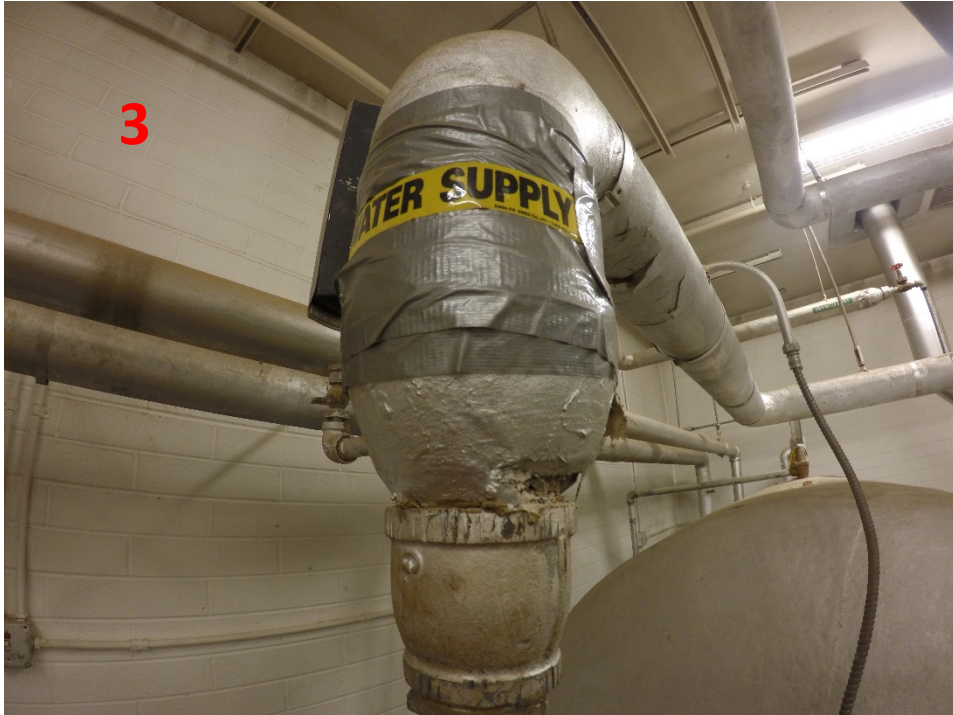
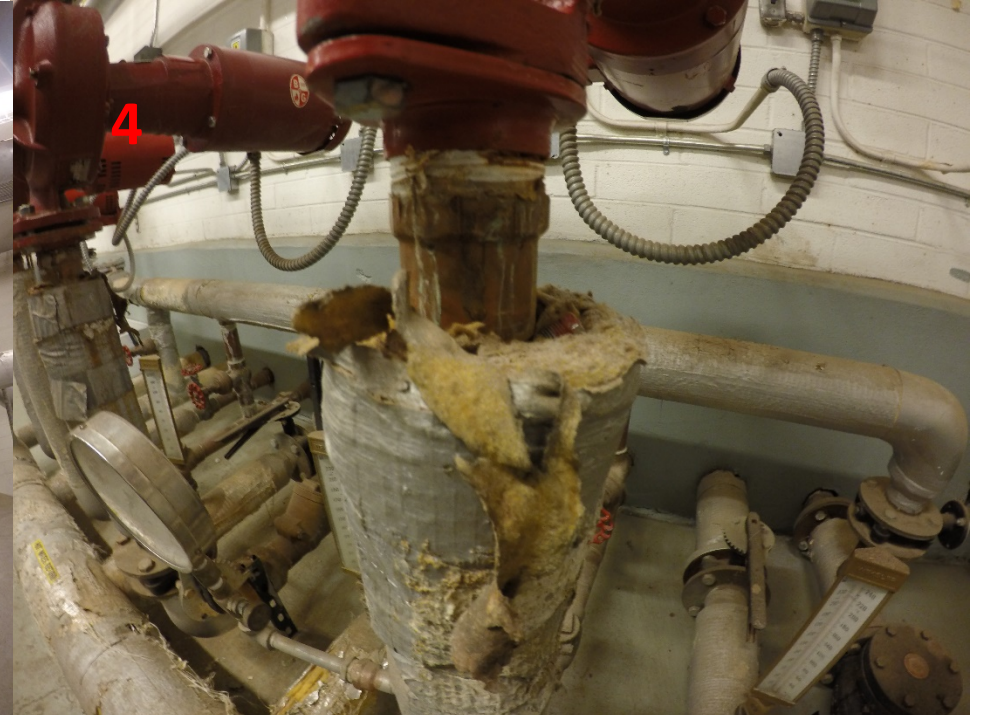
- The main water lines are made of tran site (asbestos containing) pipe and through time these pipes have become brittle and are cracking causing water leaks throughout the school campus. The waterlines in the buildings are made of chrome₁ and galvanized pipe₂. *
- We installed water filters_{4b} * on all the water fountains for our students because hauling in bottle water became too expensive (our water tastes like iron)
- On more than one occasion, our Residential students stayed in a hotel in Bloomfield because of no water or heat.

- There is a serious need for a filtration and water treatment system for the school campus.
- Our water has a high level of mineral deposits causing pipe corrosion, sediment built-up.

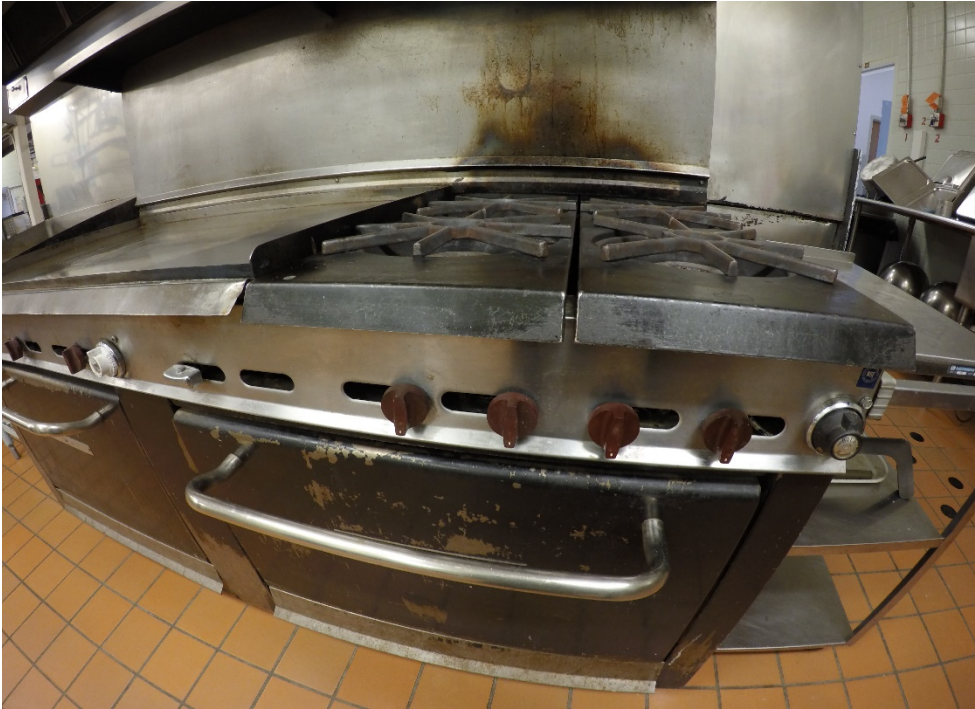
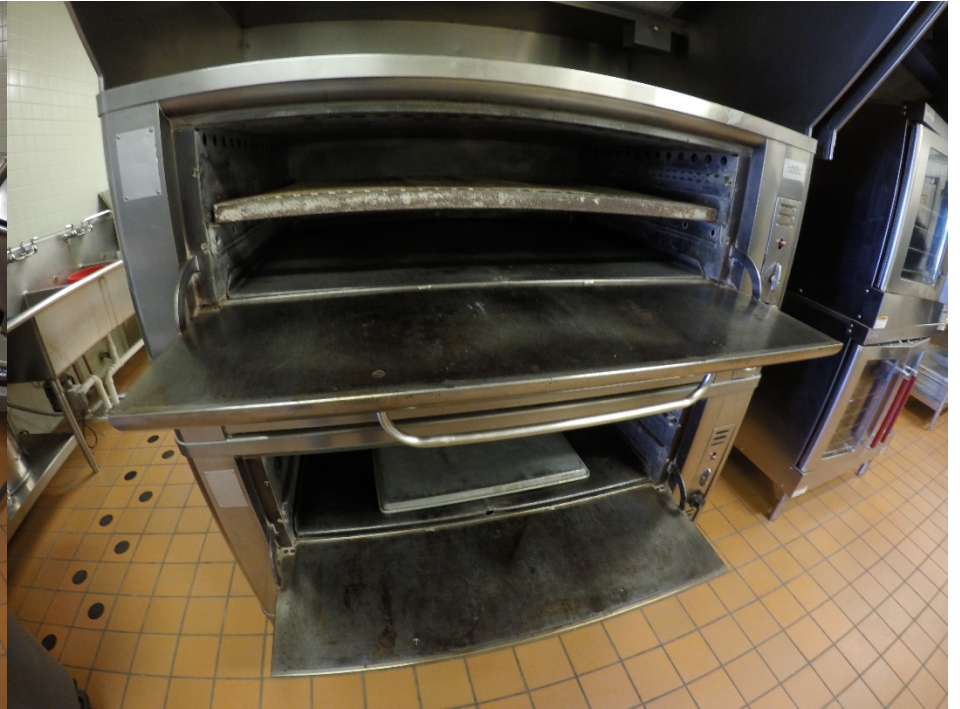
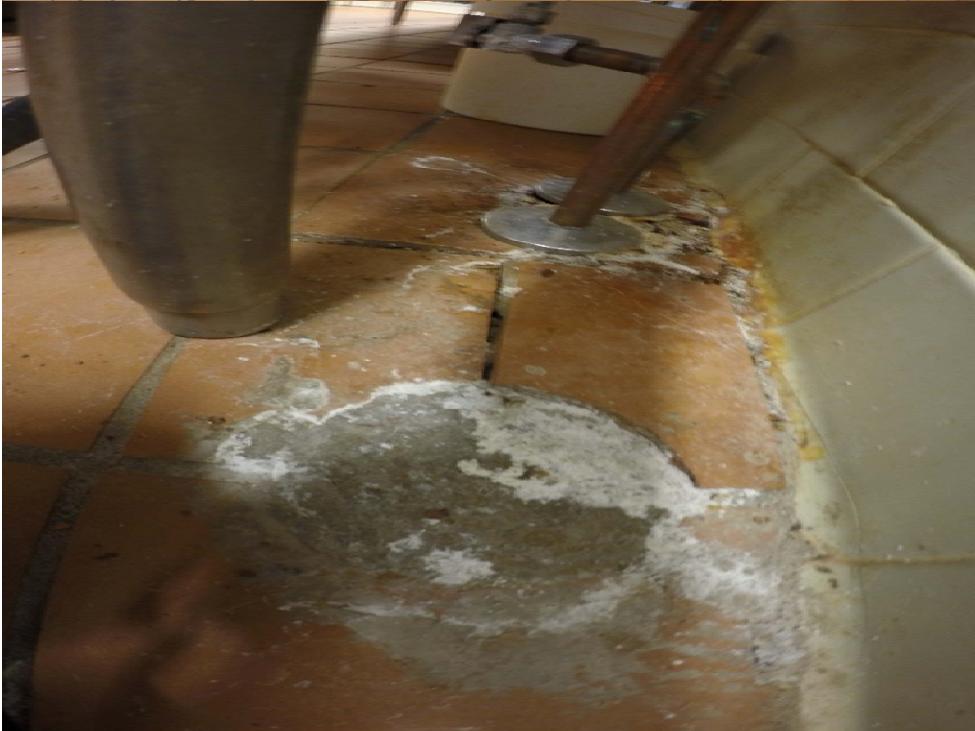
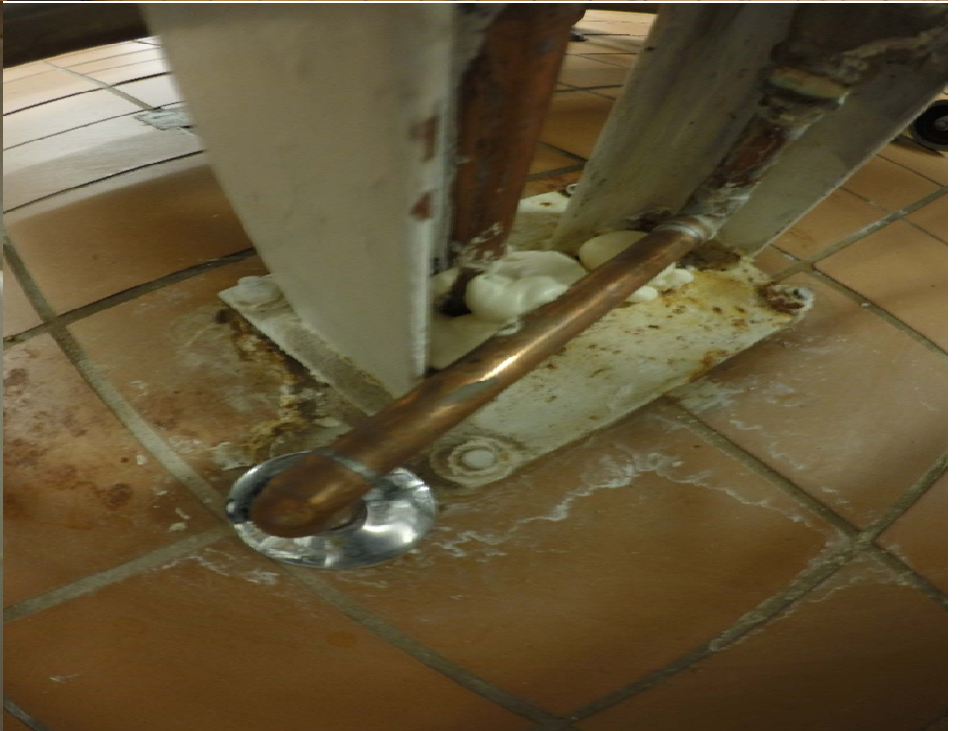
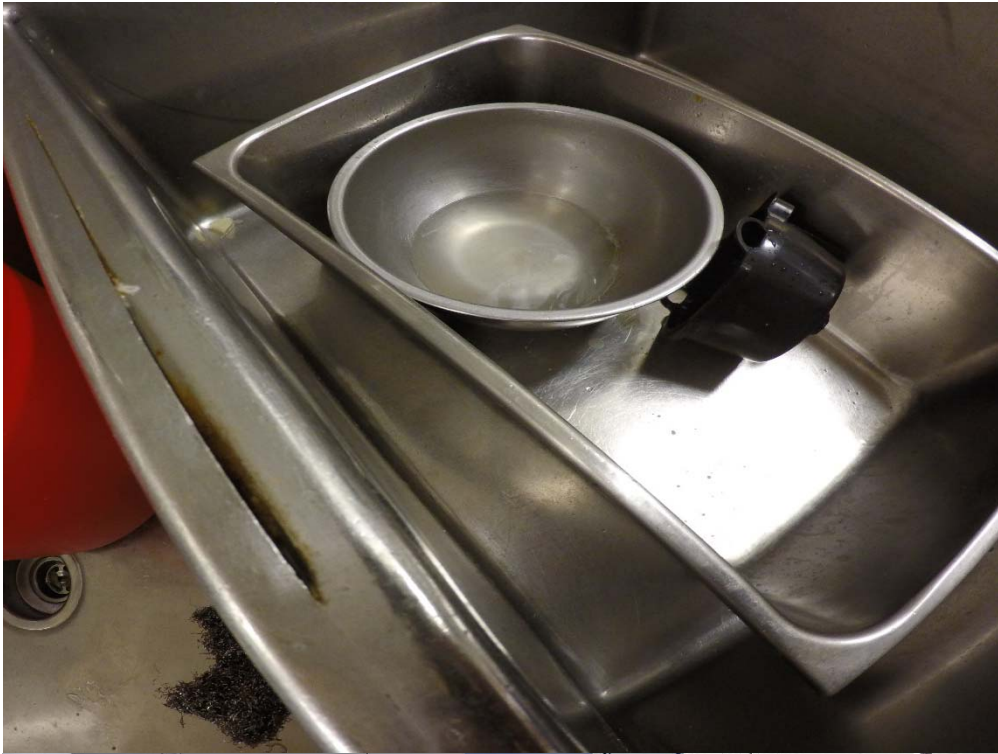
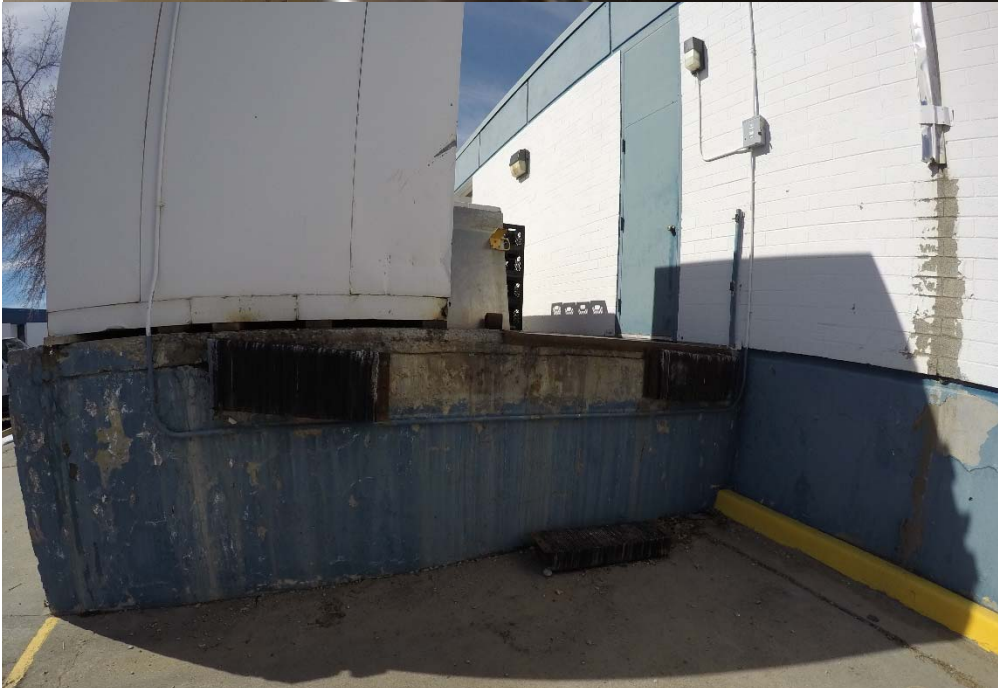
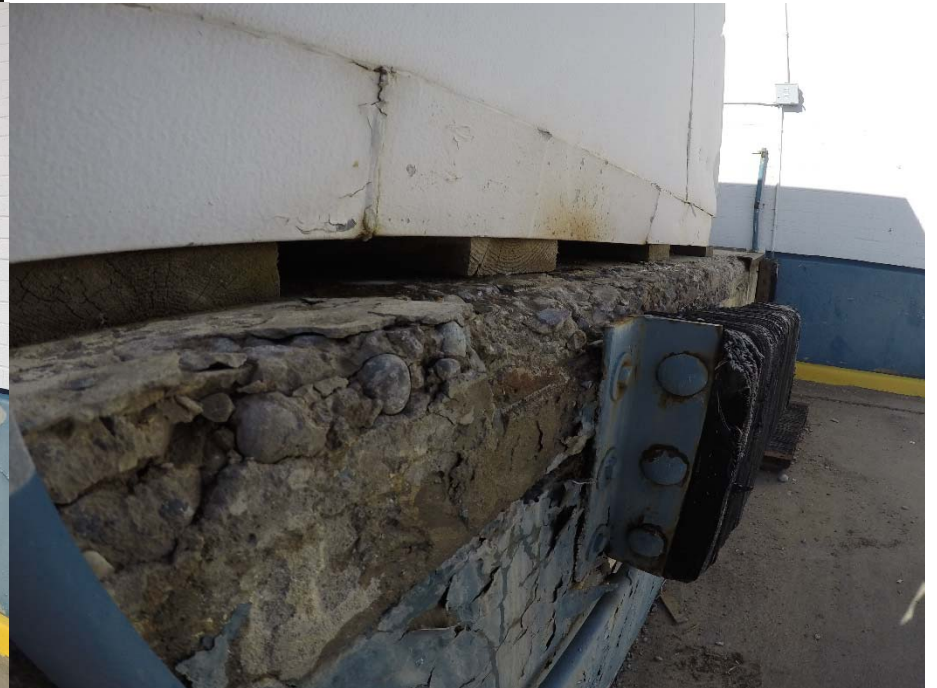
- Equipment in the kitchen have exceeded their life expectancy. Most of them have been built with the school and some were donated from the Intermountain Indian School when it shut down in 1984 (32 years ago).
- The kitchen layout, equipment, exhaust fans do not meet current codes causing inefficiency.

- Pizza oven is used to bake and cook when the ovens go out.
- Serving line burners do not work properly to maintain food temperature.
- There are problems with the walk-in freezer & cooler in keeping temperature consistent. On weekends and holidays the kitchen staff rotate to monitor the temperature.
- Loading & unloading docks concrete are brittle, crumbling and are very unsafe.

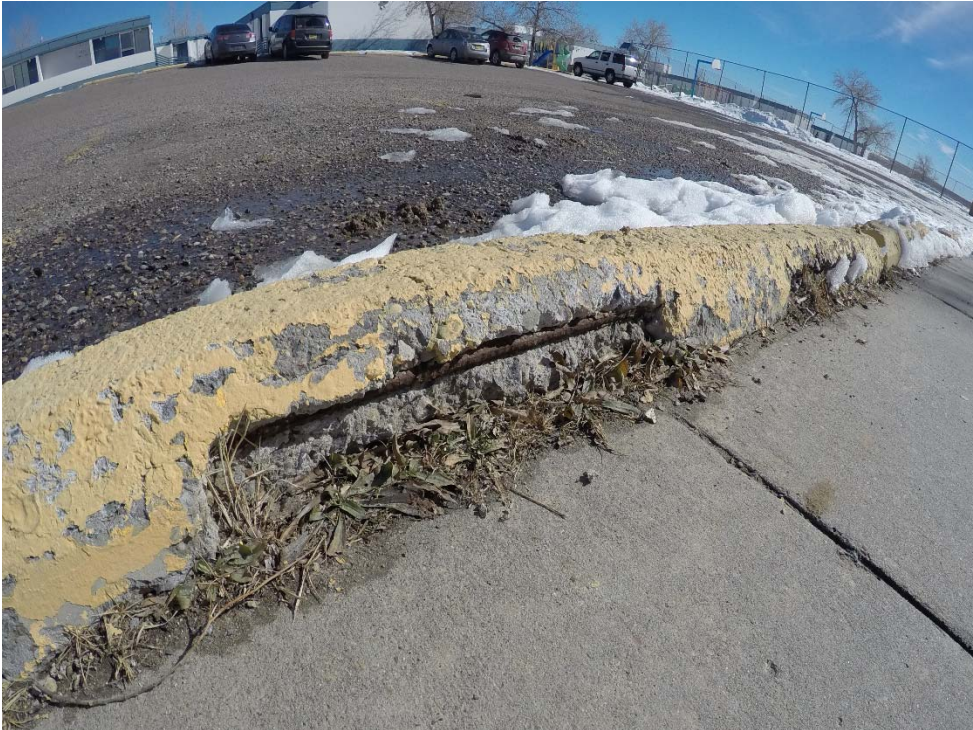
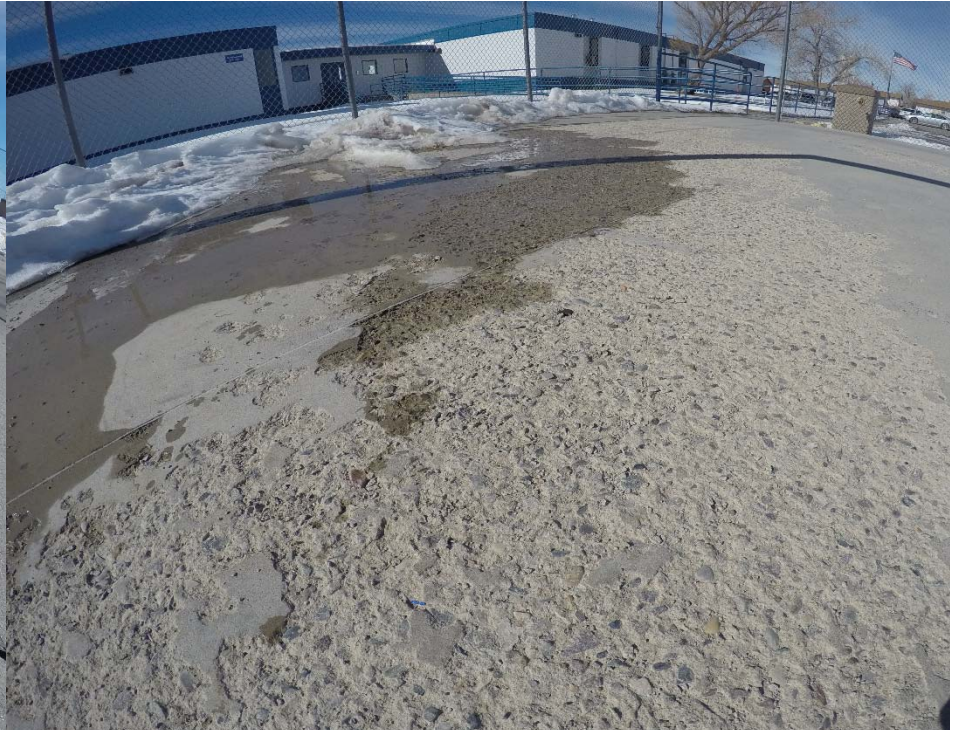
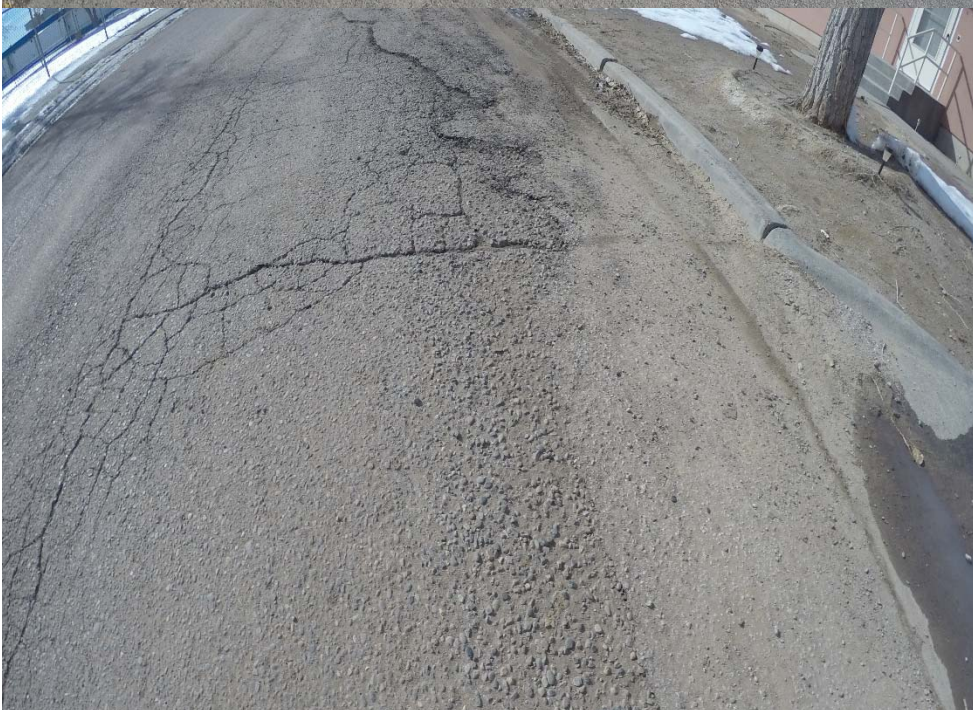
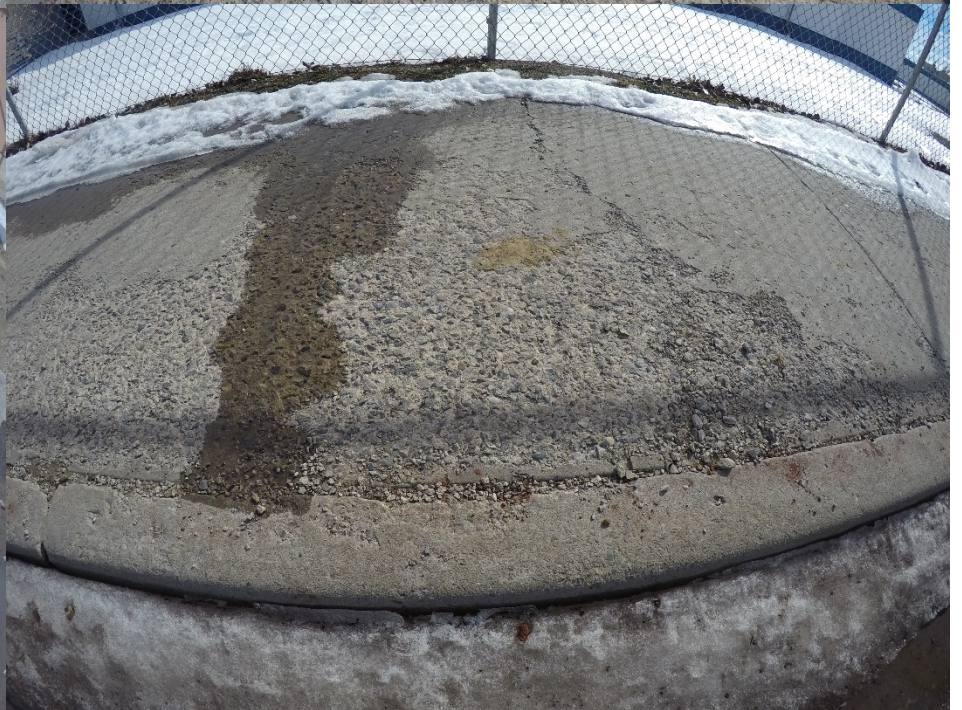
- Our school is located in a lower elevation which results in rain runoff creating ponds on our school property because of inadequate drainage system.
- During the monsoons, these ponds attract mosquitoes and other insects subjecting students and staff to bites

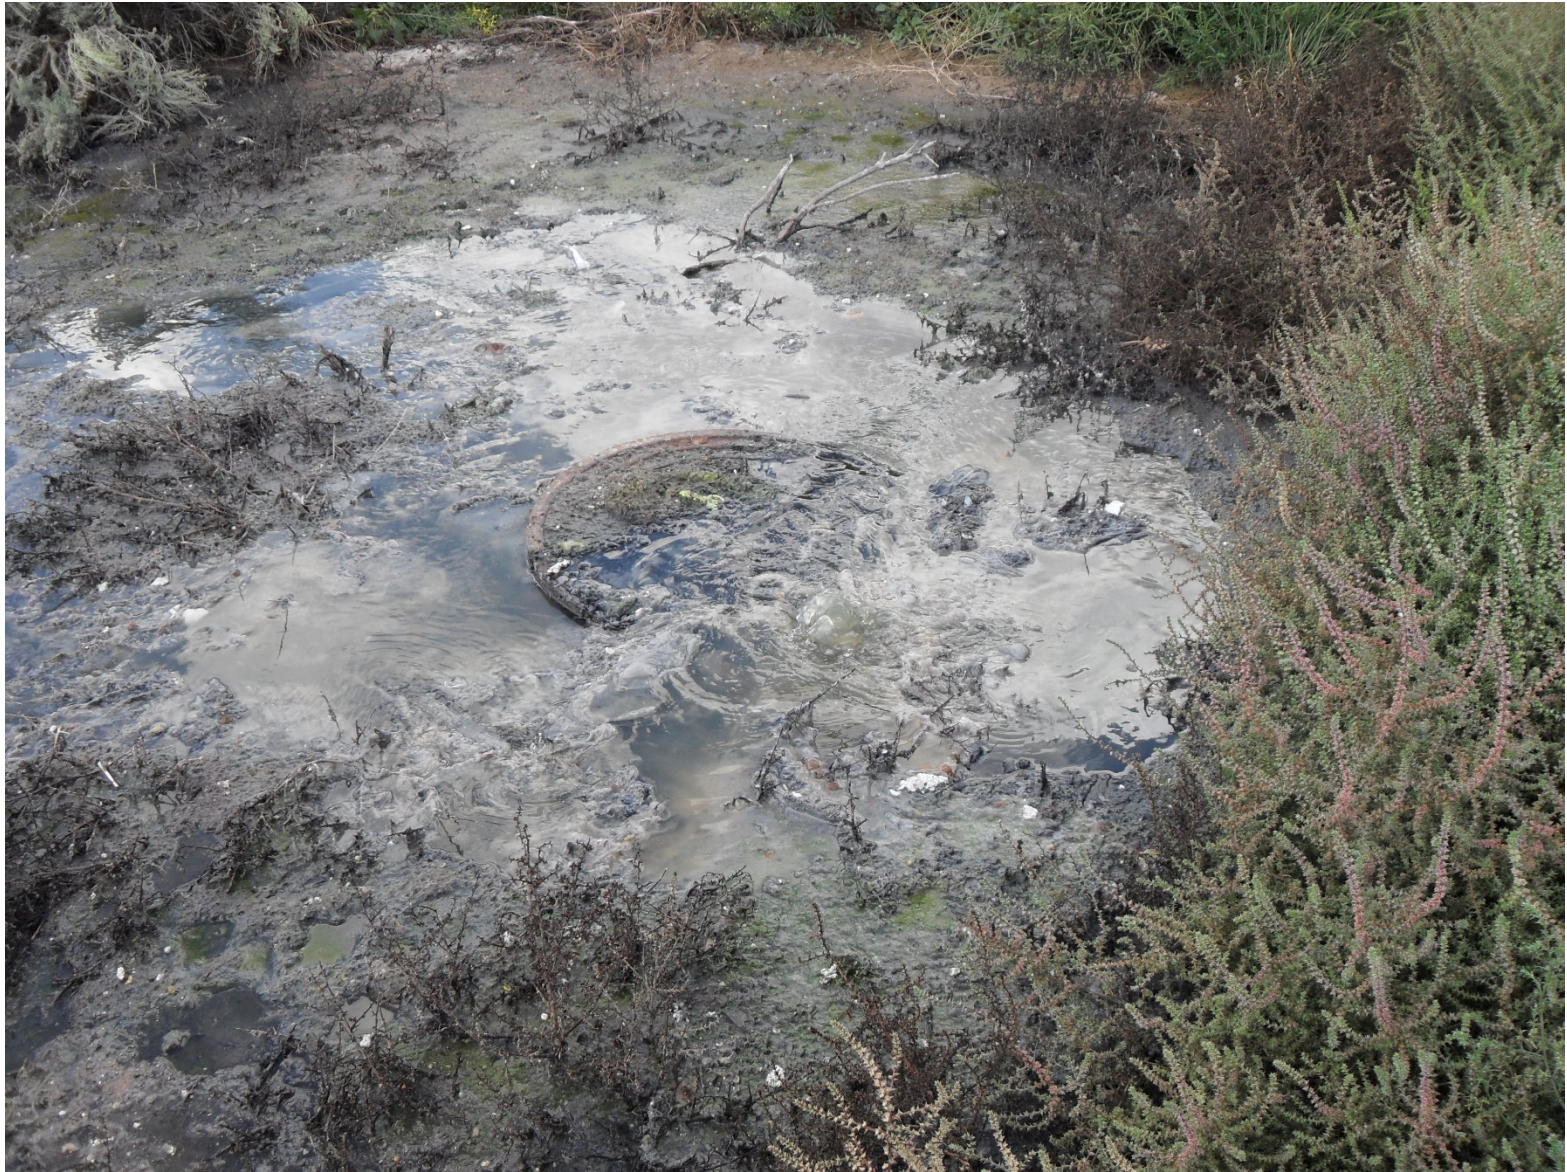
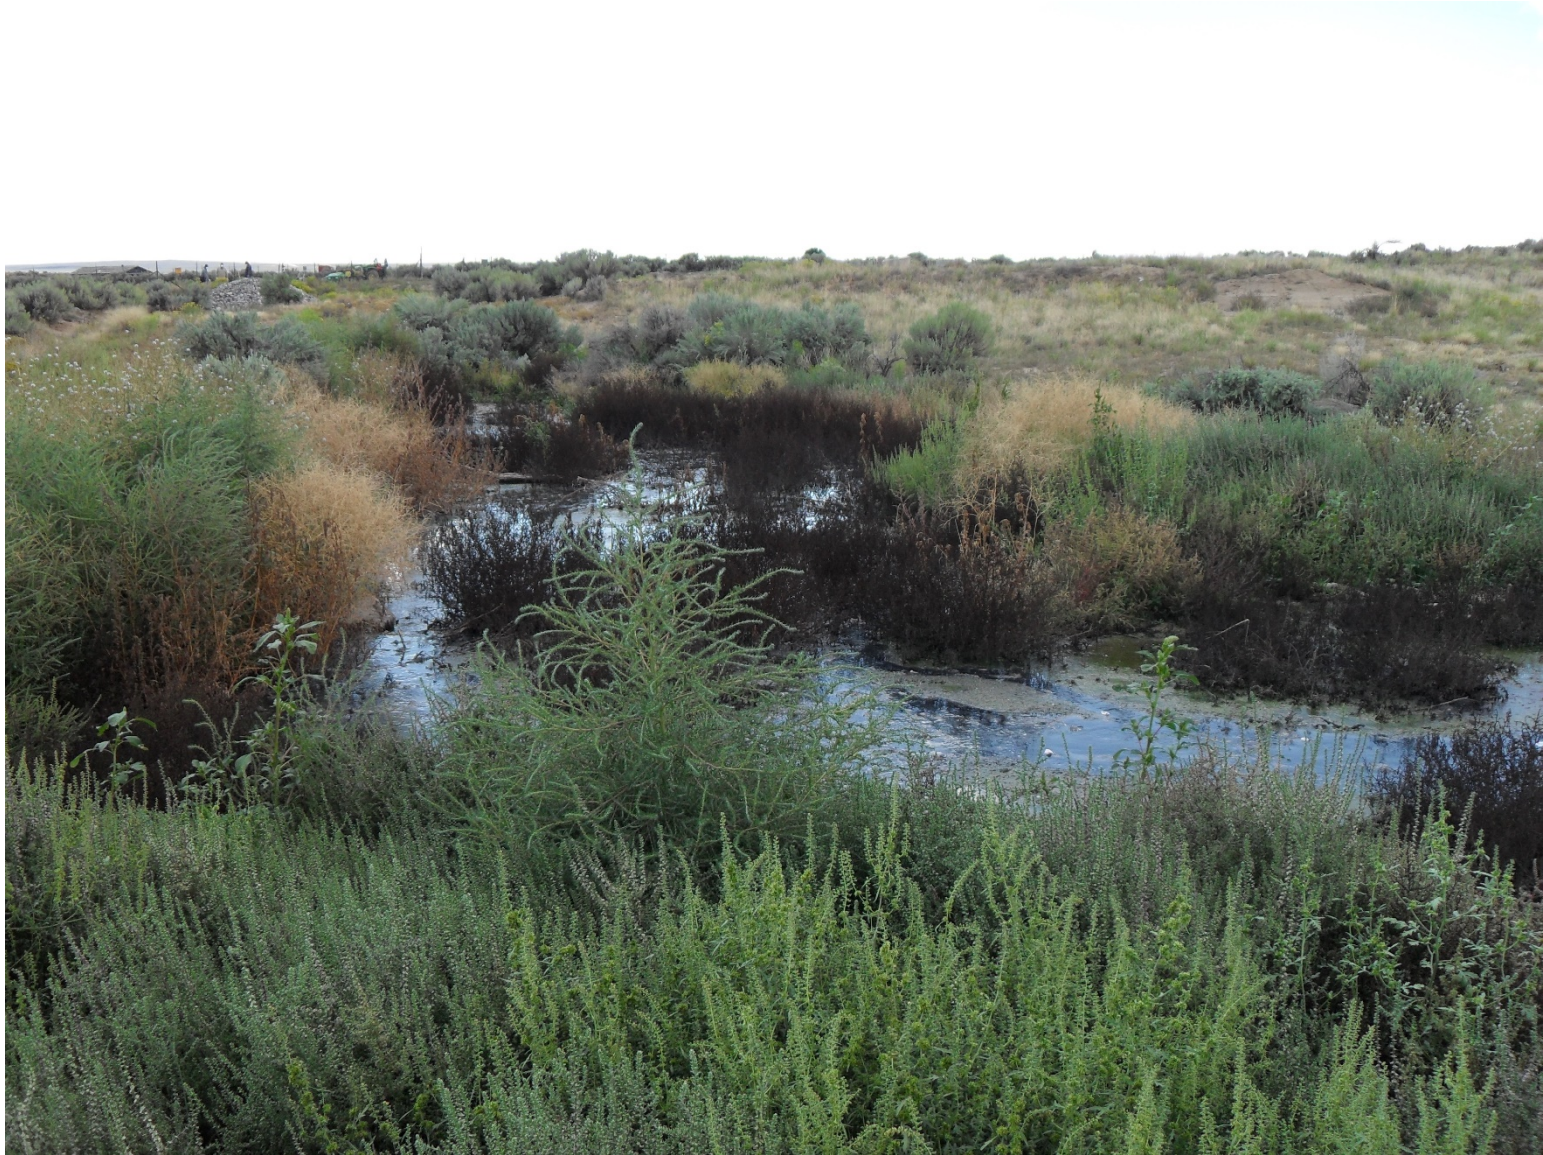
- The sewer lagoon & the manholes needs upgrading, we have to flush out the manholes biweekly to prevent overflows.
- In 2012, the sewer lagoon backed up and overflowed due to the lines being plugged.
- The sewer lines must be corrected as a long-term solution and to avoid further spills into the environment.
